120 W. PENNSYLVANIA AVE.

BA - 1431
MAG-0314314508

INVENTORY FORM FOR STATE HISTORIC SITES SURVEY

120 Pennsylvania Avenue, Calvary Parsonage

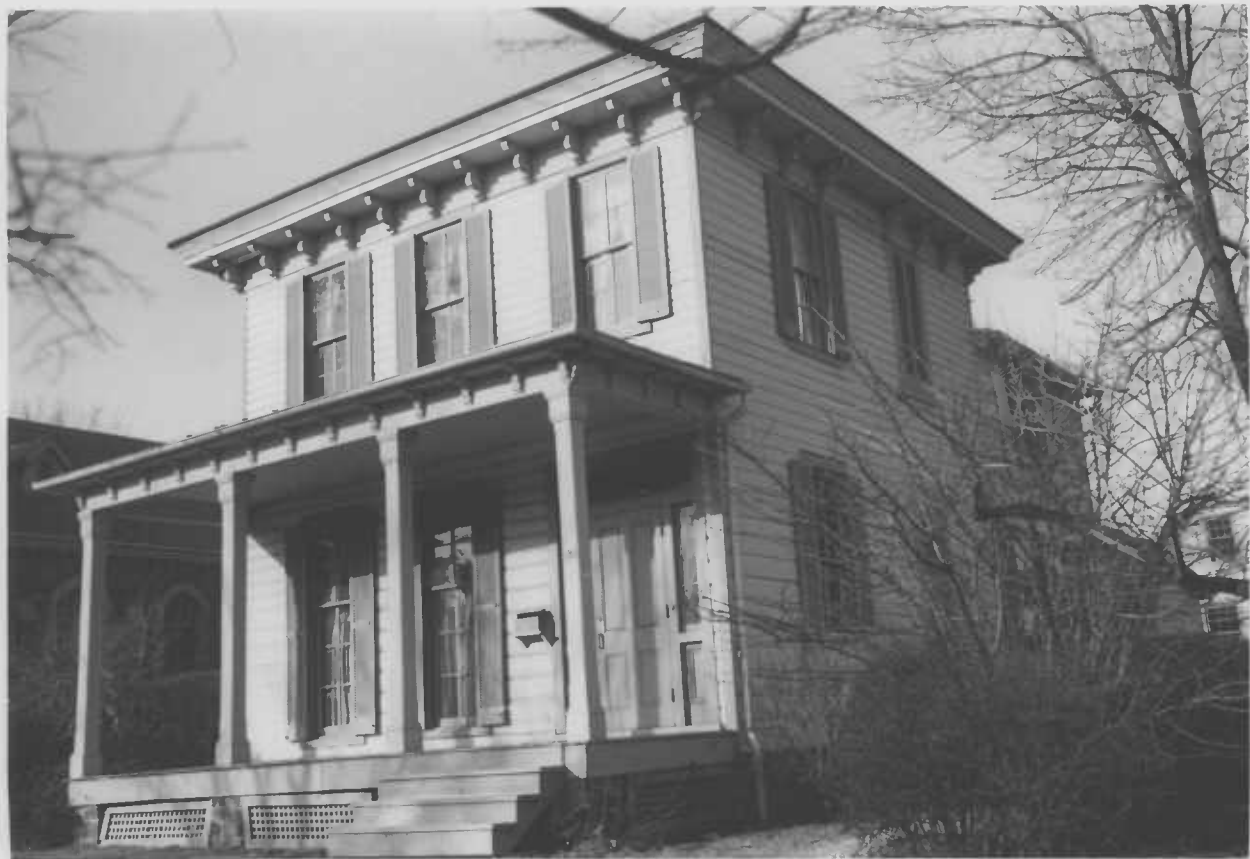
120 W. PENNA. AVE.
S.E. CORNER

The south or main facade of this Italianate house is three bays wide. The house is two stories high and is covered with unusually wide (7") bevel siding, (Old German siding). The house rests on an uncoarsed stone foundation and the roof of the house is made of a type of flat metal which may be the original roofing material.

On this south facade there is a single story porch which is as wide as the house. The roof of the porch is supported by four square chamfered columns.

The two windows on the first story are large 4/6 sash windows which are surrounded by wooden shutters. The windows are probably original to the house because of the wavy appearance of the glass panes. There is a four-panel door with a four light transom above the door and three light casements on either side of the door.

The second story has three 4/4 sash windows with shutters on either side of the windows. Because of the southern exposure, high ceilings and large windows the rooms of the main block are spacious and bright.

The roof of the house is covered with ribbed sheet metal and the roof has bracketed eaves which are characteristic of Italianate buildings.

The east facade of the main block of the house is two bays deep. The two windows in this main block are 4/4 sash and there are two three light casement windows in the ground level of the main block. The second story fenestration is two 4/4 sash windows as in the first story of the house.

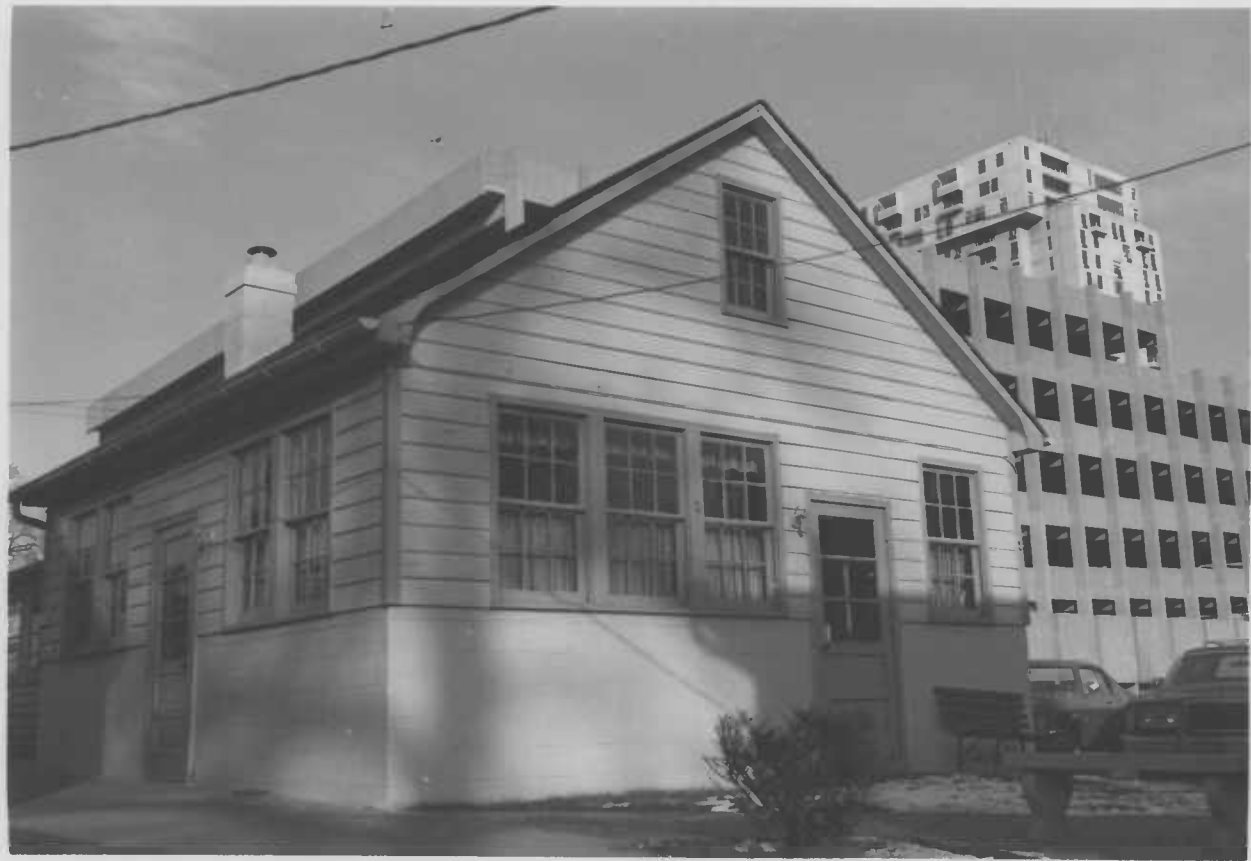
BRIDGE BLDRS. CARVIN
S.

This small cabin was built by a Sunday school class in the 1930's. According to Reverend Leland Higginbotham, there was an architect involved who helped with design plans, but the cabin was built by the students.

This small cabin is one story with a central pediment. The cinder block base measures 52" high. The upper portion of the cabin is constructed with frame and clapboards. The cabin has a shingle roof and measures 22' in width and 24' in length.

The south or main facade is five bays wide. There are four 6/6 sash windows and a door on this facade. The central pediment has a small 6/6 sash window that is centrally located.

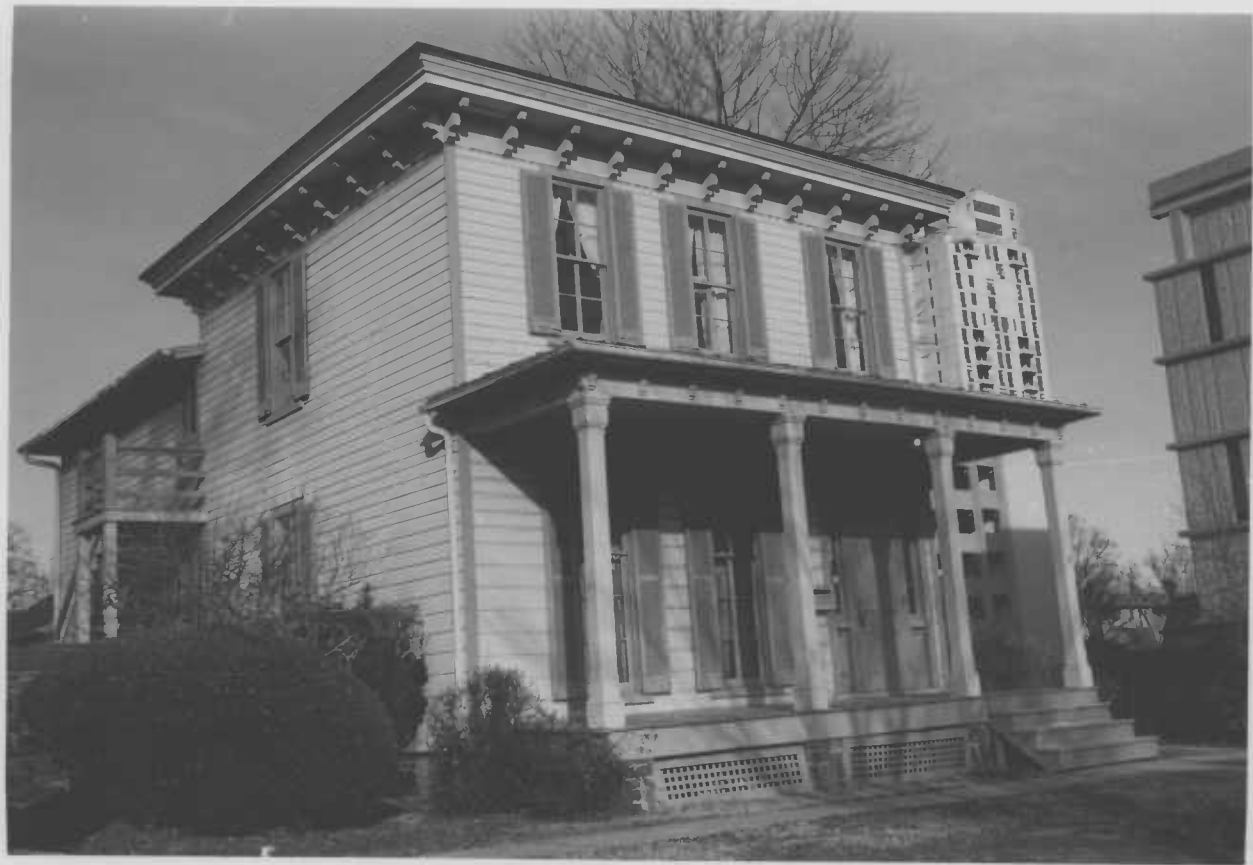
120 W. PENNA AVE
S.W. CORNER

The west facade of the building is three irregular bays deep. As witnessed in the east facade, the additional bays make this facade and the east facade seem irregular in design.

The first story window has three 4/4 sash windows with shutters on either side of the window. The second floor has an outside entrance. There is a small porch outside the door that is supported by two long, narrow railings.
